MRA District Conditions Analysis and MRA Designation Report

Adopted by the Village Council, March 9, 2021

SITES
SOUTHWEST

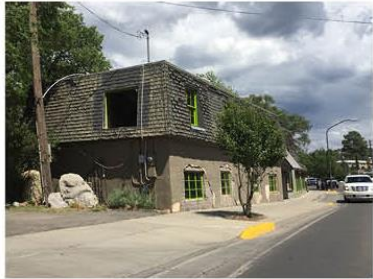
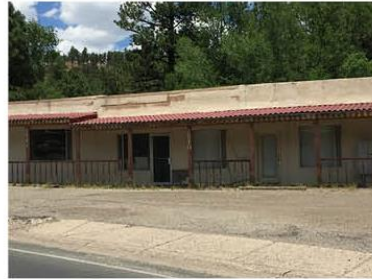
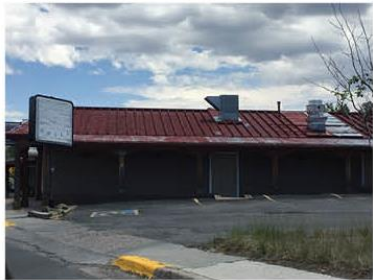
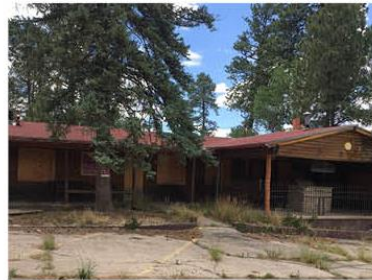
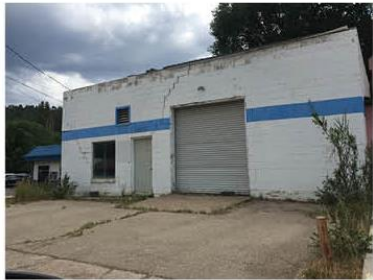
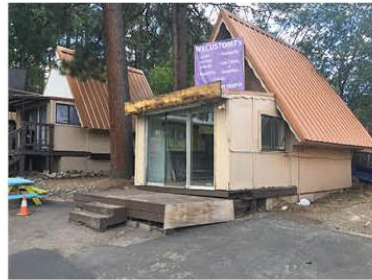
Deteriorated Buildings and Site Conditions

The Village of Ruidoso depends on a thriving commercial district to support its tourism-based economy. Within the corridor are vacant and occupied structures that are deteriorating because of a lack of investment. Even some occupied buildings have deteriorating facades and foundations. Signs of deterioration include boarded up windows, peeling paint, crumbling or poorly patched stucco, crumbling foundations, and deteriorated wood features.

Following the maps are photographs that illustrate the deteriorated buildings and sites and closed businesses along the corridor.

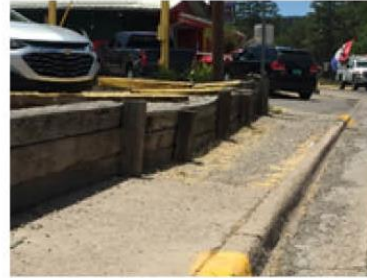
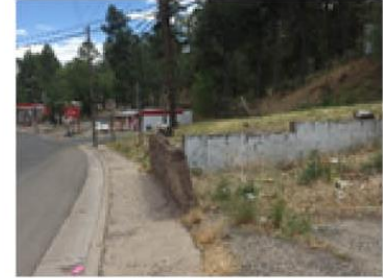
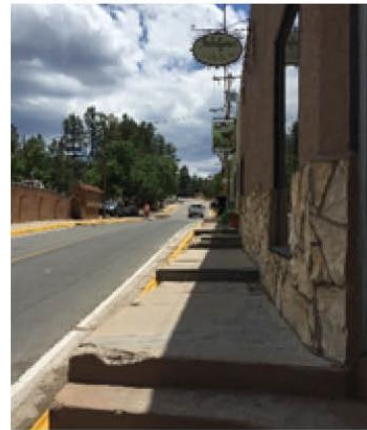
Deteriorated Site Conditions and Sidewalks

Deterioration of site or other improvements include crumbling asphalt parking lots, neglected landscaping, weeds, deteriorating retaining walls and cracked and broken sidewalks and steps,

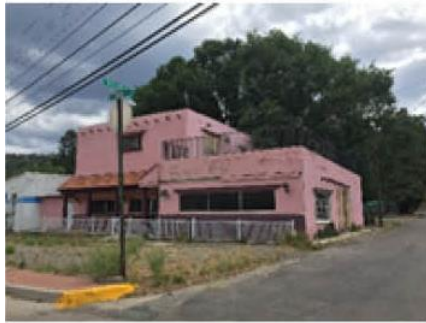
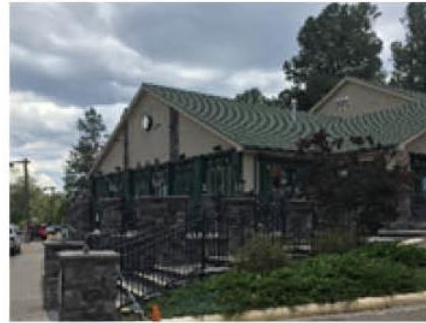
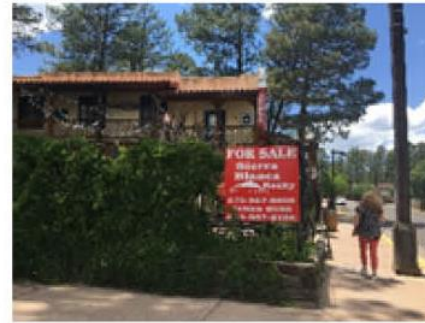
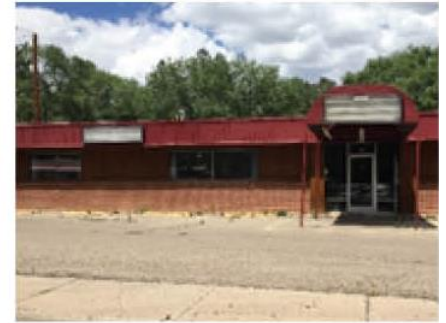
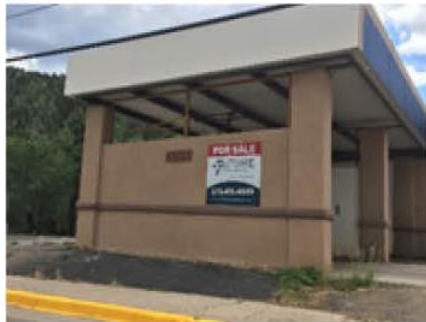
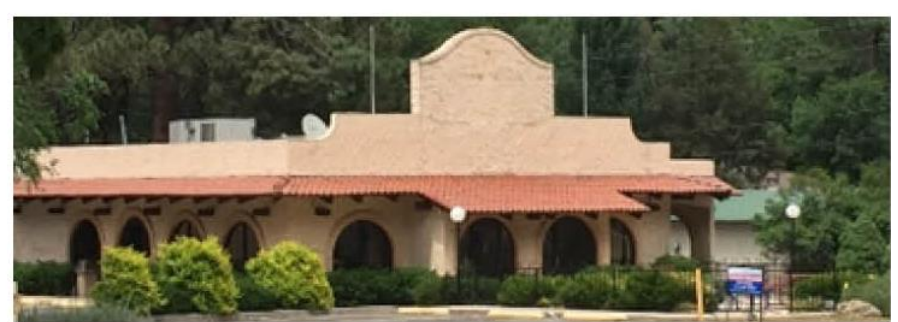
Vacant or Closed Businesses

There are 35 properties that are currently for sale or rent. Some buildings are vacant, and stores are closed, threatening the continuity of business activity along the corridor. A lack of investment in these properties is contributing to deteriorating conditions along the corridor and creating pockets of inactivity and neglect. There are also well-maintained buildings that are not for sale or rent but have been vacant or businesses have been closed for a year or more.
